FORT EGBERT AND EAGLE, ALASKA

❧ A PRESERVATION PLAN ❧

National Trust for Historic Preservation in the United States
740-748 Jackson Place, N.W.
Washington, D.C. 20006
Prepared Under Contract for the Bureau of Land Management

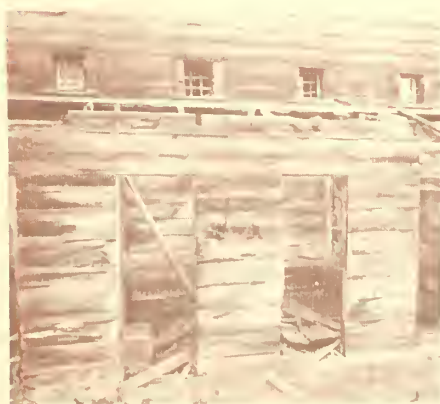
Figure 25. Condition of mule barn foundation at west end. Note angled shearing of post top in foreground. (Clark)

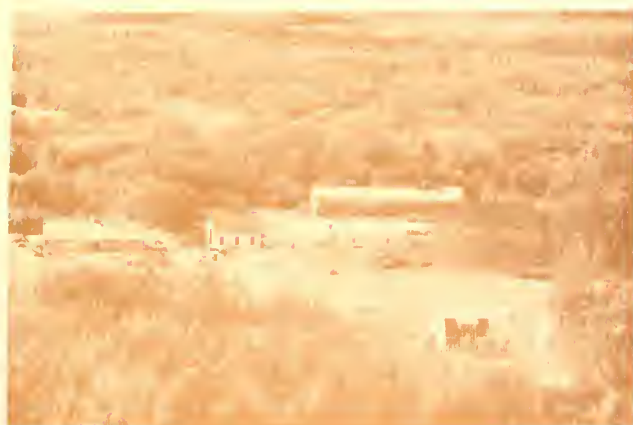
Figure 29. Remaining Fort Egbert buildings, with stabilization work under way on all but the stable, right rear. Open area in center is the old airstrip. (Volz)

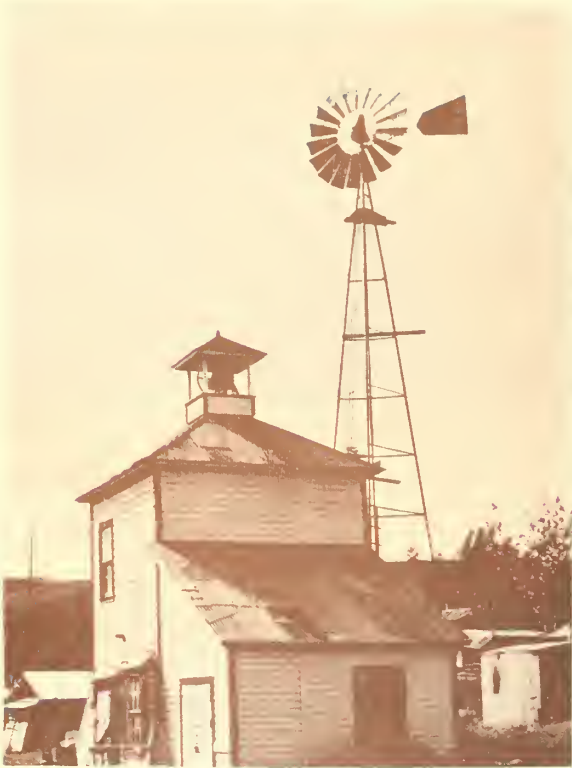
The well house is essentially in sound condition. The principal concern is the capability of the building structure to support the water tank when filled to capacity. While supporting posts can accept the vertical load, the lateral strength of the well house is suspect.

Figure 48. The well house and windmill, built in 1910 at a cost of \$3,000, have served as the principal source of Eagle's municipal water supply for more than 65 years. (Volz)

Principal work consists of stabilizing foundations where they may have deteriorated and structurally reinforcing the building to allow maximum use of the water tank. At the same time work is done on the structure, a new metal-bestos chimney should be installed, storm windows installed and the building repainted duplicating its original colors.

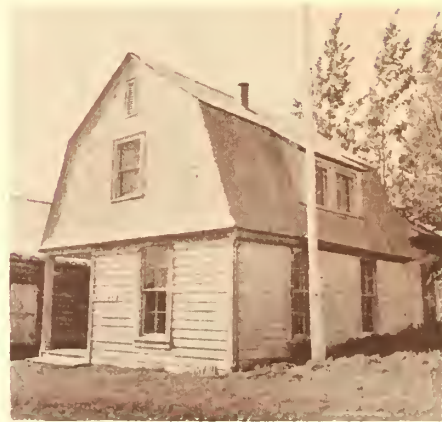
Typical of wood structures in Eagle, this building suffers from general foundation deterioration resulting from direct soil contact. Moreover, when moved, the sections of the building do not appear to have been properly aligned and joined. Some deterioration is evident at the intersection of the wings. The rear wing is in a general deteriorated condition.

Figure 49. The Historical Society of Eagle building was built in 1900 and altered in 1902 for use as an NCO quarters at Fort Egbert. In 1915 the house was moved to Eagle and became the custom house until it was adapted for its present use. (Scott)

The building should be raised and a crawl space excavated and drainage established. Foundation members and deteriorated joists should be replaced and the building realigned on a new foundation. A soil cover should be placed between concrete or soil and wood materials. All wood should be properly treated to arrest further deterioration.
